Open Degradation on ITO Lines for an LCD Driver

Peter Jacob, Empa Dübendorf Dept. 173

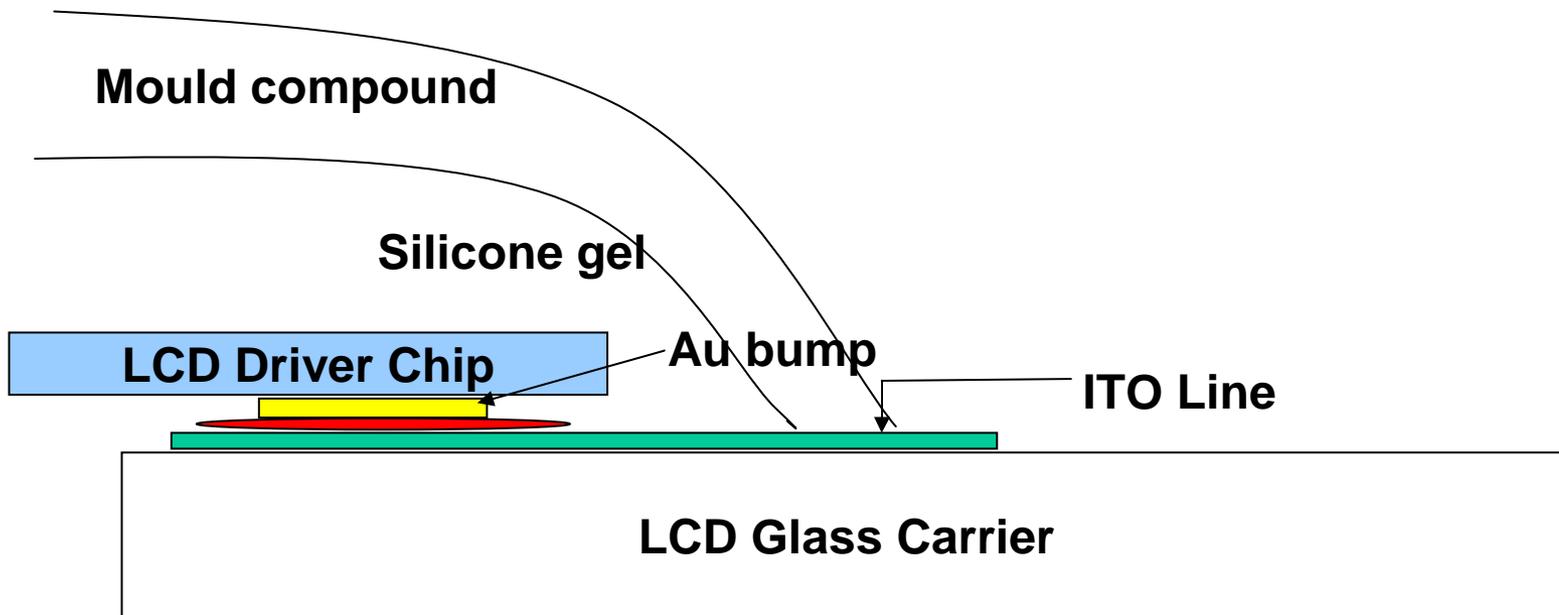
- LCD-driver IC directly glued onto connecting ITO lines on LCD glass
- Glue includes silver particles
- 2-step protector: soft silicone gel and hard top mould compound

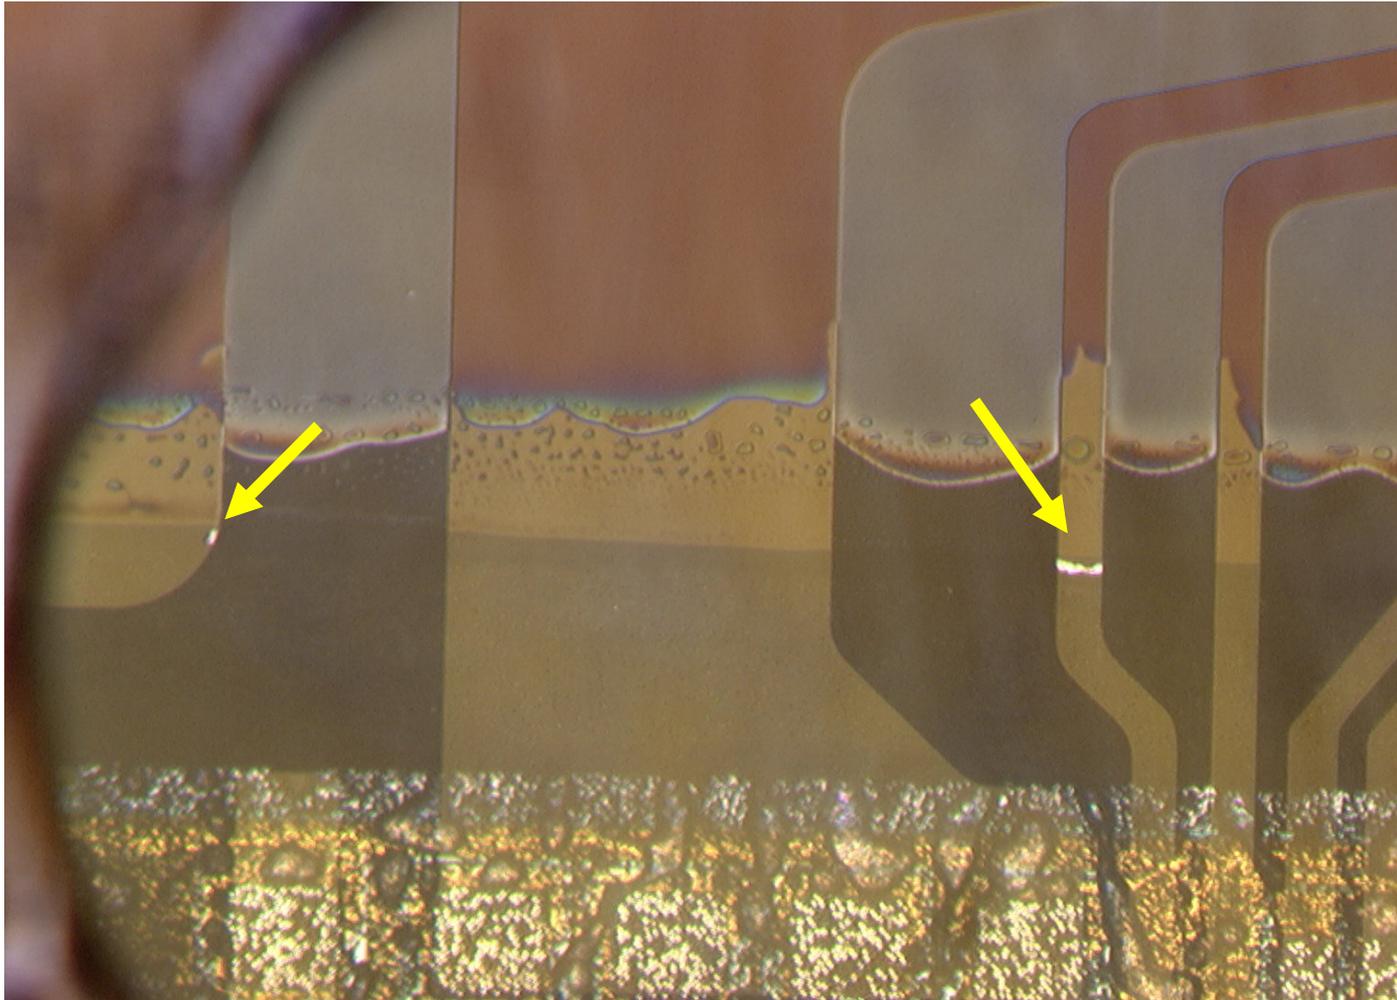
Optical setup, image taken through the glass

Optical microscope inspection has always shown the same attack points: one small line right from the big one was completely open, the wider line right from the thick one never was attacked

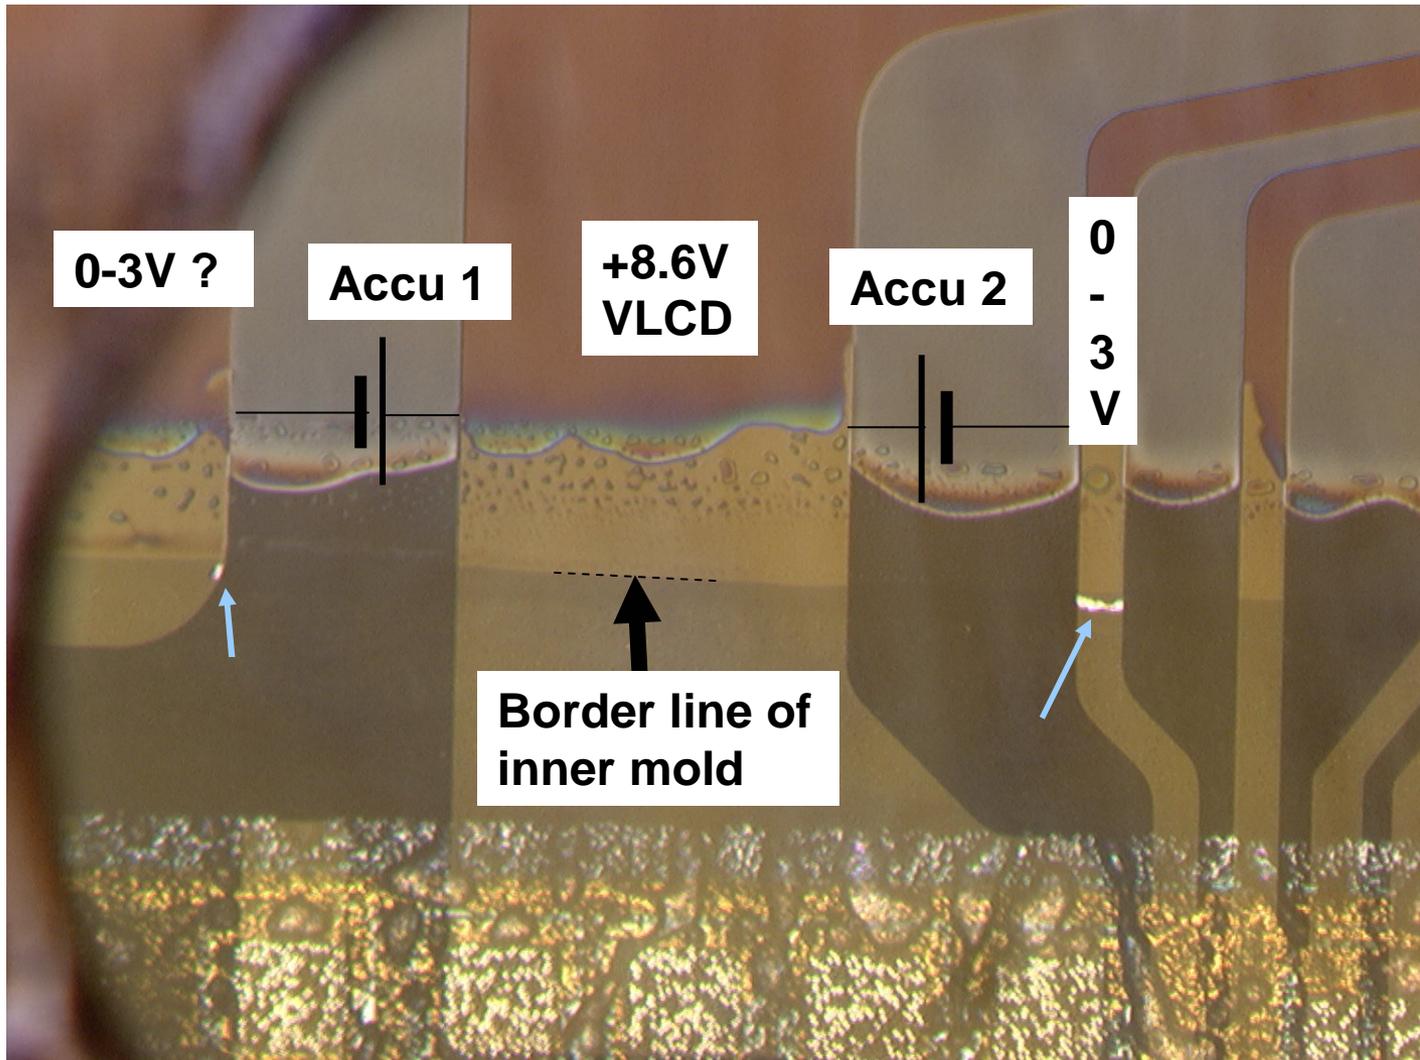
Voltage Potentials and electrochemical evaluation of the situation

VLCD is the line with the maximum potential on-site. Compared to neighbour potentials, electrolytic cells have been generated, consuming material of the „minus“ side.

- Humidity and electrical field strength can generate electrolytical reactions on LCD-ITO lines – finally causing opens
- Device and ITO/ LCD layout should consider to arrange pins in a manner which avoids abrupt potential changes of neighboured lines. Vdd and Vss lines are best arranged at corners, where enough space is available to reduce field strength
- After a suitable redesign enhancing critical spaces, no further reliability problems occurred
