Open Degradation on ITO Lines for an LCD Driver

Peter Jacob, Empa Dübendorf Dept. 173

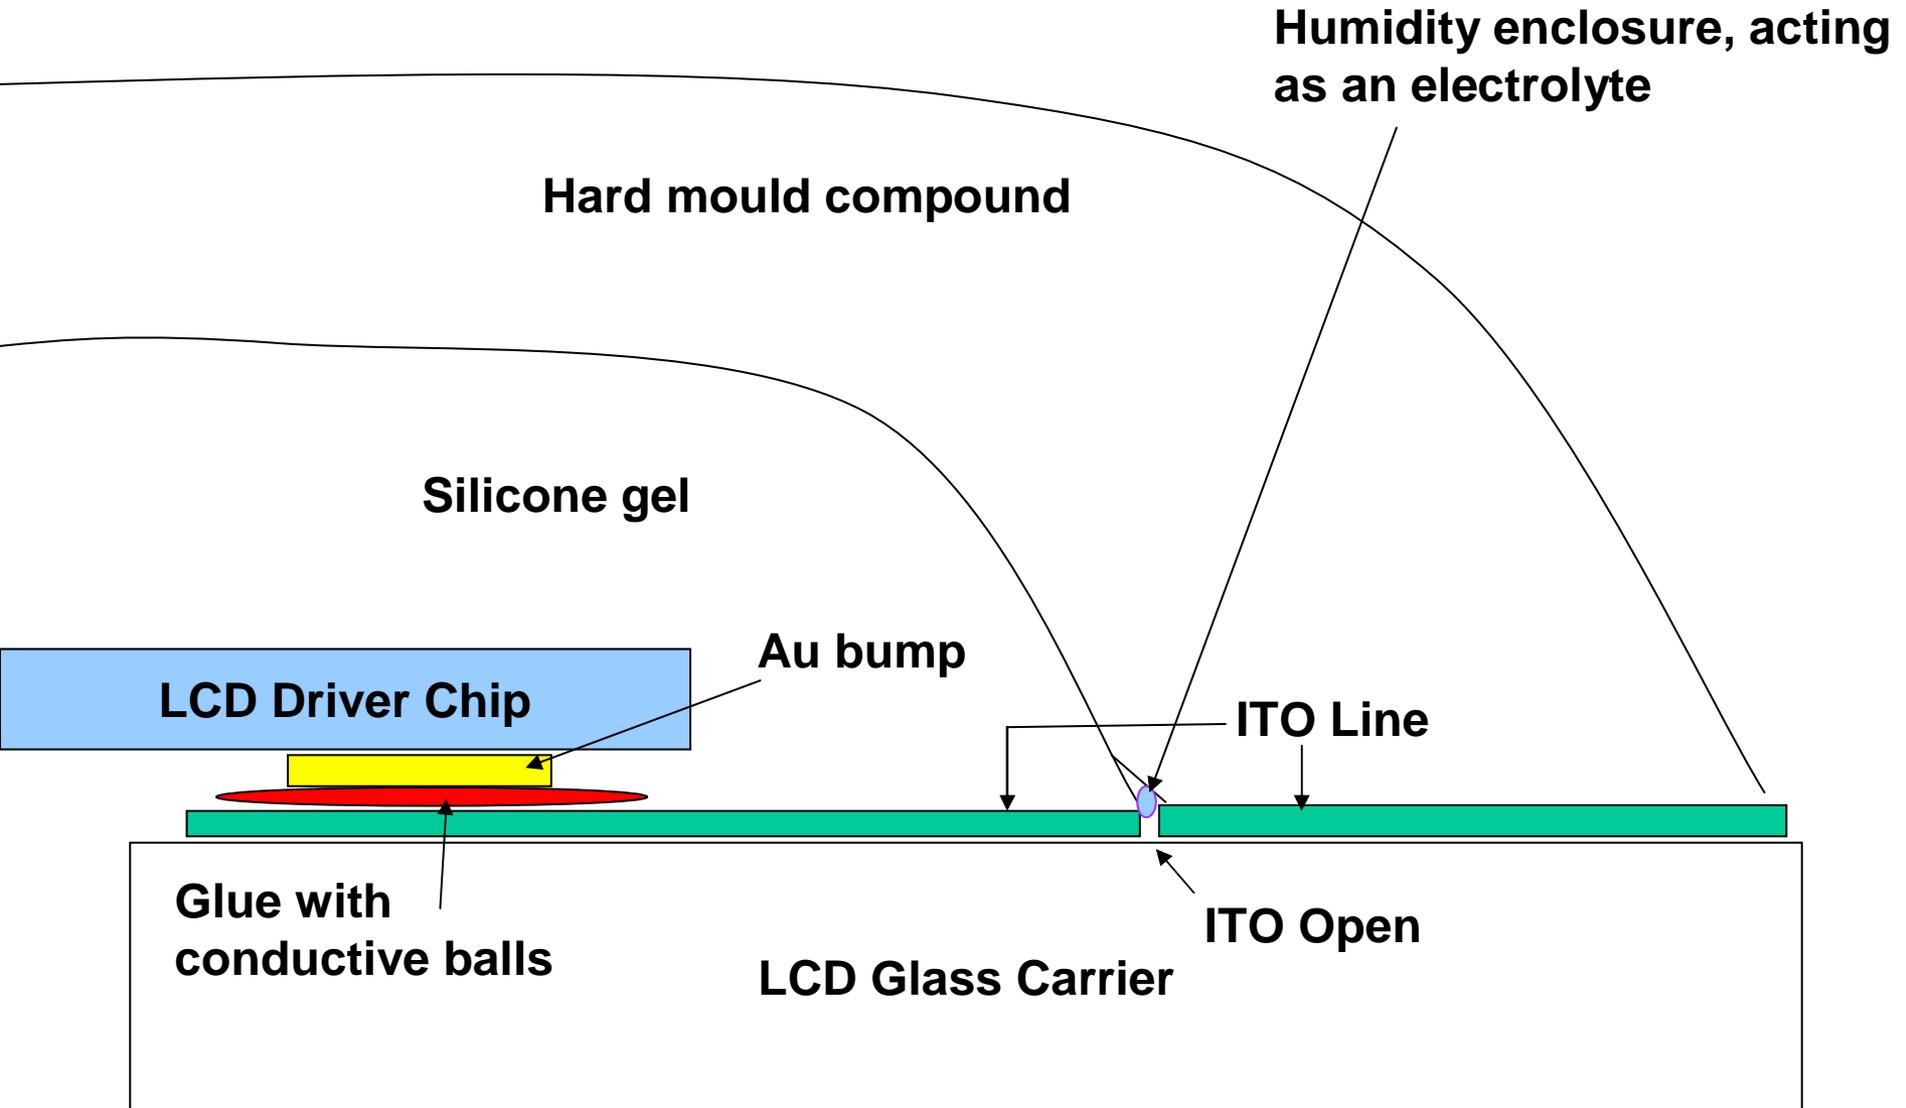
Cross sectional drawing

VLCD is the line with the maximum potential on-site. Compared to neighbour potentials, electrolytic cells have been generated, consuming material of the „minus“ side.

- Humidity and electrical field strength can generate electrolytical reactions on LCD-ITO lines – finally causing opens
- Device and ITO/ LCD layout should consider to arrange pins in a manner which avoids abrupt potential changes of neighboured lines. Vdd and Vss lines are best arranged at corners, where enough space is available to reduce field strength
- After a suitable redesign enhancing critical spaces, no further reliability problems occurred
